Chartered Surveyors

LEVEL 2

Your survey and valuation report

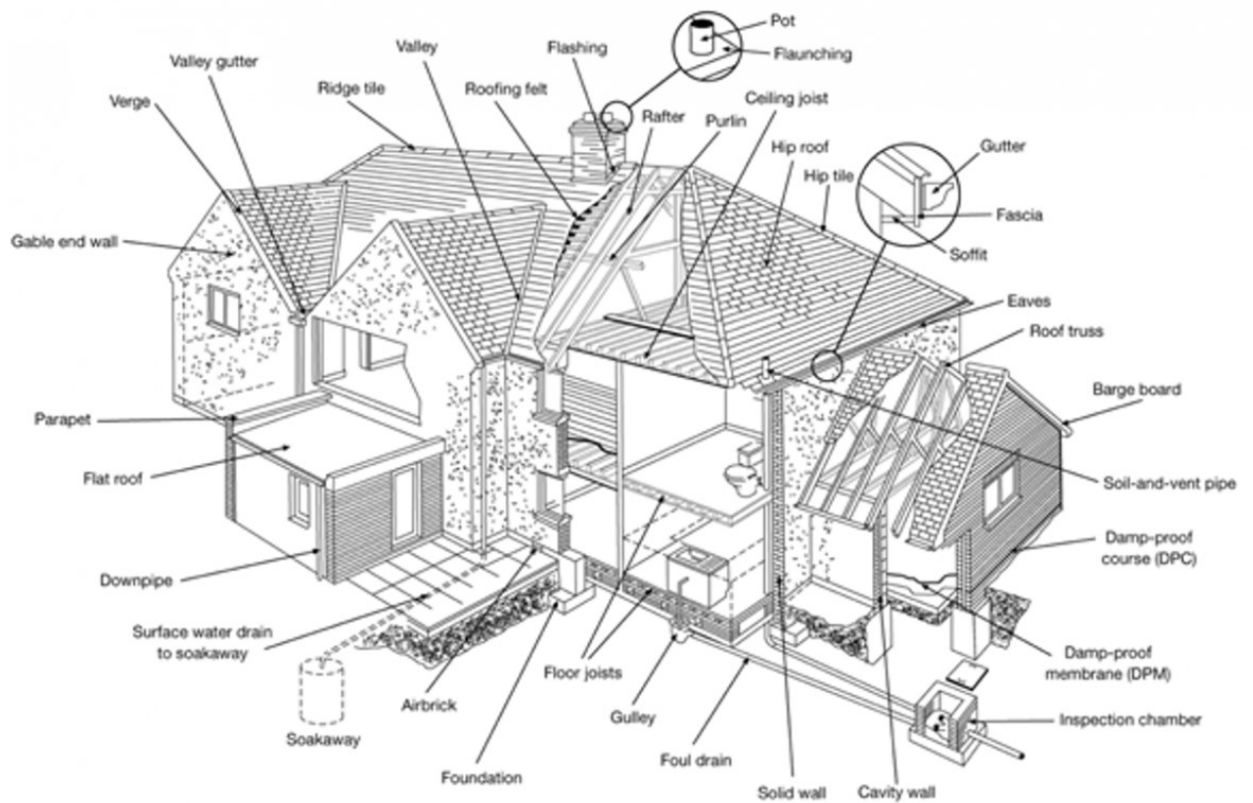
N Typical house diagram

This diagram illustrates where you may find some of the building elements referred to in the report.
